## PROGRESS REPORT NO. 1

## PERFORMANCE OF RIGID PAVEMENTS CONSTRUCTED ON GRANULAR BASES

February 1, 1956

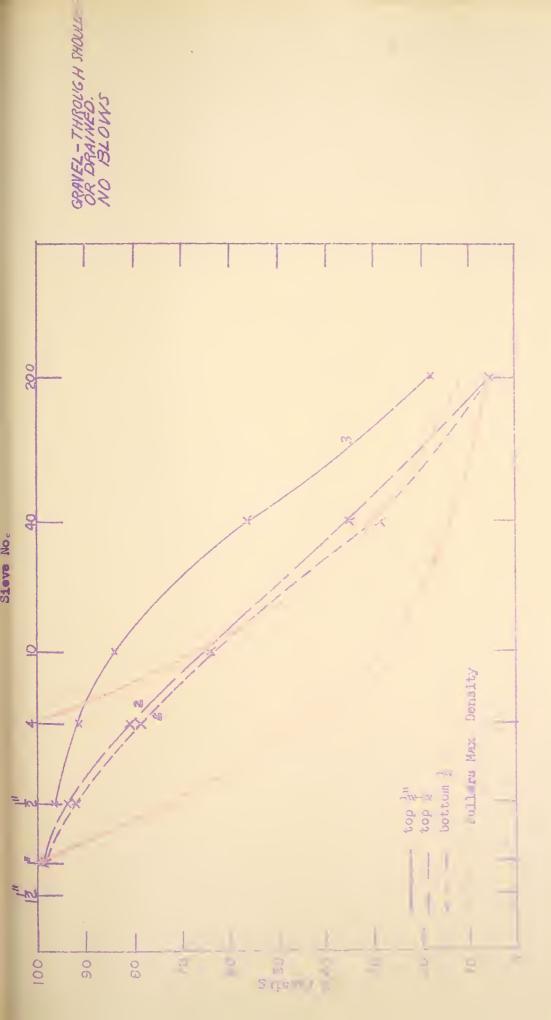
Fig 4

In addition, it will be noted in Figures 4, 5 and 6, that the second stage development of blow holes has not as yet caused a removal of fines from the base included in these graphs. This is not surprising since these are relatively new pavements and it can be reasoned that pumping action has been in effect for just a short period of time.

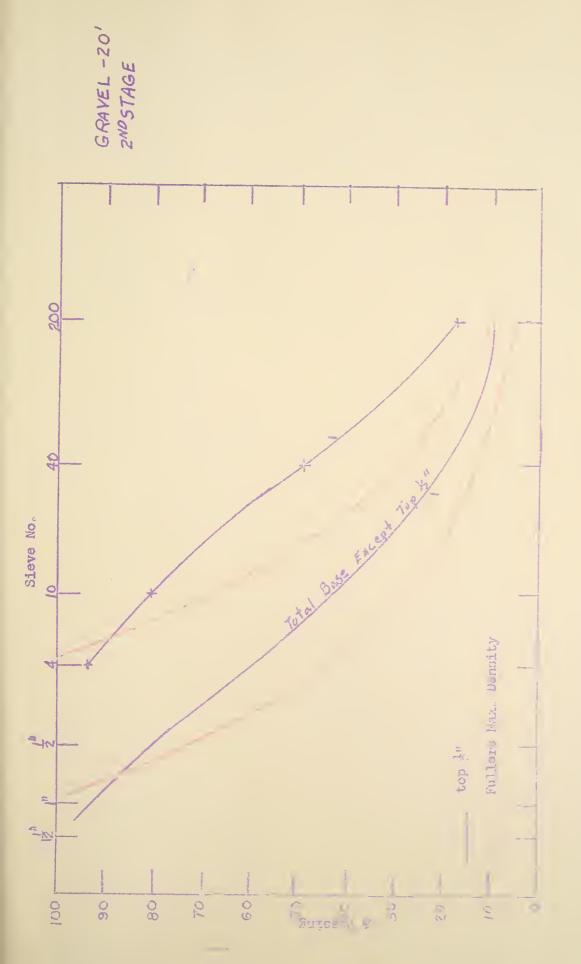
Fig. 16

It will be noted in Figures 1 through 16 that Fullers maximum density curves are presented along with the actual average curves. Fullers curve was calculated by means of the following formula:

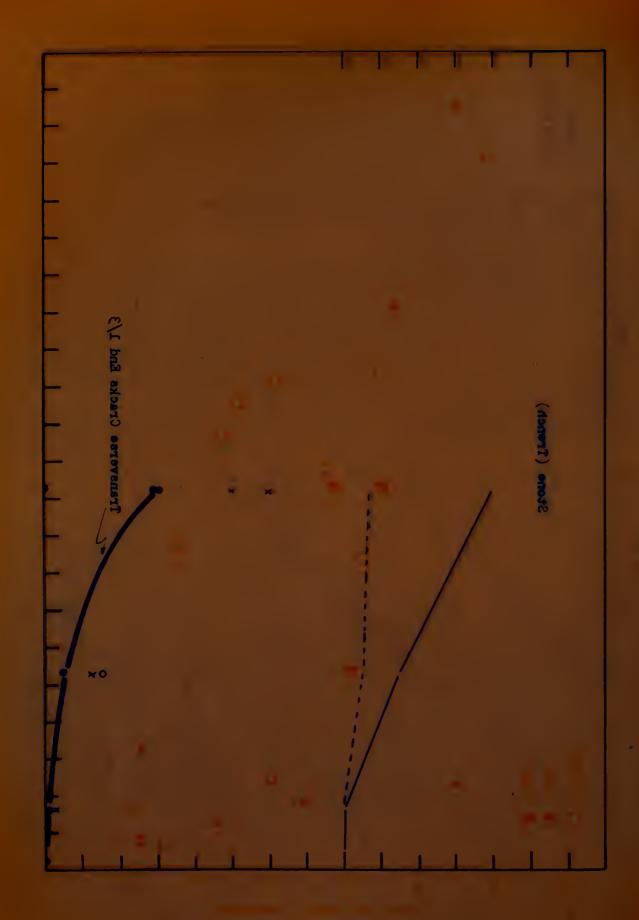
Fig. 17 Effect Of Repetition Of Loads On Number Of Cracks (Gravel, Trench Construction, Traffic Lanes)

Figure 17, with three overlays, shows the variation of performance with traffic. For these curves an estimate was made of the total number of repetitions of 18,000 pound axel loads during the life of the pavement. These data were calculated using the method proposed by Hveem (2). These data show that the occurrance of transverse and restraint cracks increases sharply beyond 16 x 10<sup>5</sup> repetitions of load. Also it will be noted that the pavements using gravel bases show greater tendency towards restraint crack formation than do those on sand and stone. The data indicate that the severest blowing occurs at about 20 x 10<sup>5</sup> repetitions and that it apparently is retarded at later stages. It can also be seen that blowing is active primarily on gravel bases. Stone bases have resulted in extensive first stage blowing but very little second stage. The orange overlay shows roughness data for each of the roads. It will be seen that sand and stone bases result in slightly higher roughness values for comparable traffic than do the gravel bases.

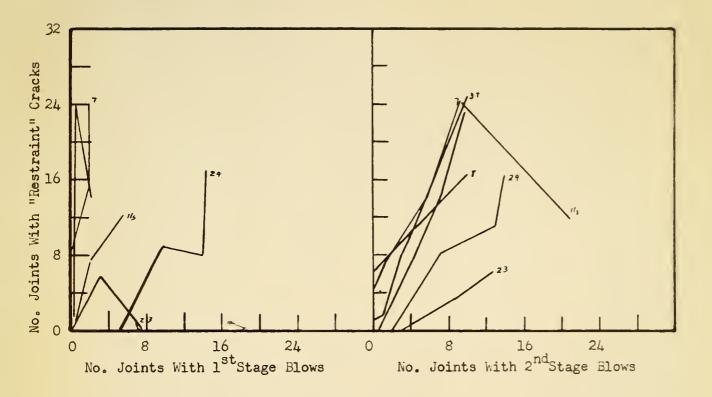
Effect of Tile Drains, U.S. 52 (Rase Through Shoulder Except as Noted) F1R. 18

Drainage is most important and is tied in closely with permeability,

(See Figures 18 and 19). Practically no blowing was found where shoulder

drains were used, or where clean, well graded bases were used in through the
shoulder construction. Bases constructed of stone through the shoulder have

functioned very well. Gravel bases (poorly graded) constructed through the
shoulder have shown serious distress regarding blowing and formation of cracks,

Shoulder drains constructed in these latter materials have shown little distress;
however, some evidence exists that these too are becoming defective.

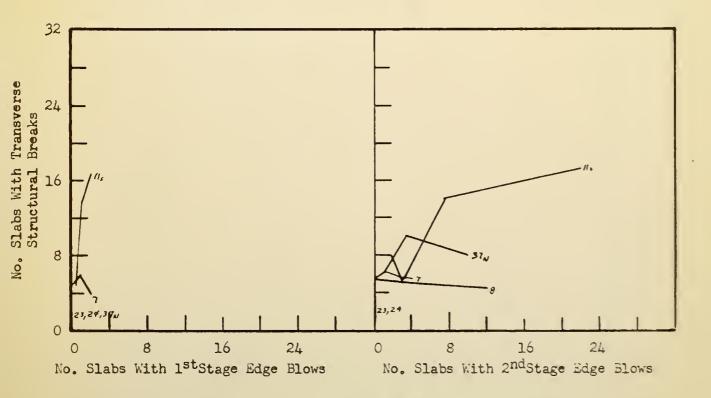
Fig. 20 Variation of Structural Defects With Blowing (Gravel, Trench Construction, Traffic Lanes)

Figure 20 in the appendix shows the relationship of blowing to performance as measured by number of cracks in the concrete pavement. The upper curves show data for restraint cracks while the lower are for transverse cracks occurring at the end 1/3 of the slabs. These data indicate that cracking is not necessarily associated with first stage blows, but that more cracks occur when blowing has progressed to the second stage. The numbers beside the curves represent the survey stretch numbers. Therefore, each line represents data for a particular highway, but for different sections on that highway. It is significant that the sections of a given highway showing greatest distress, on the basis of cracks formation, also show greatest second stage blowing activity.
